CASE HISTORY

Repair of Corredor Sur-Tramo Marino Bridge

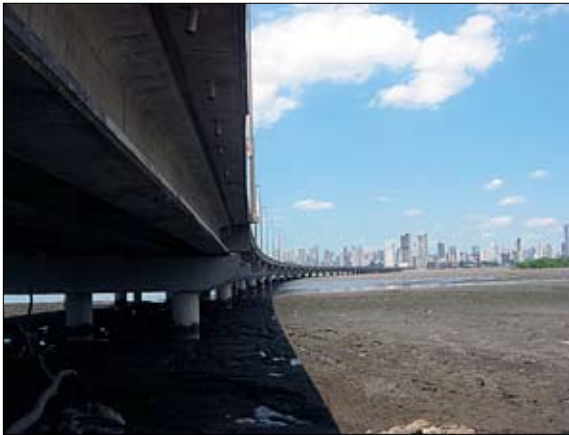
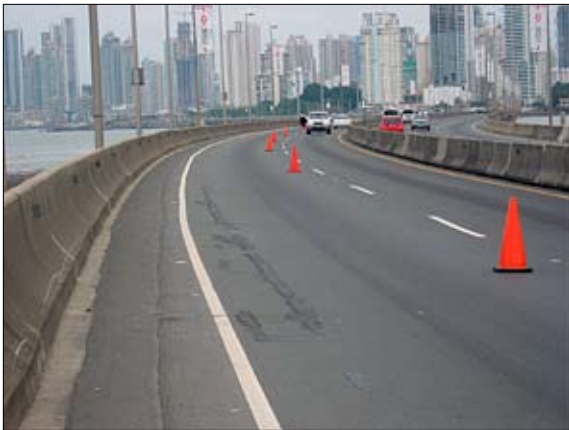
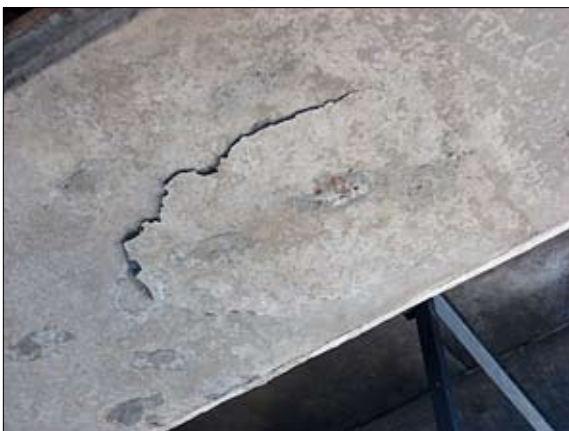
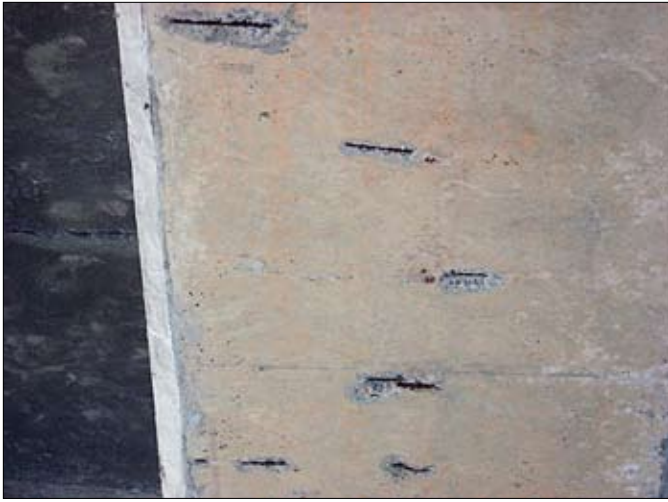
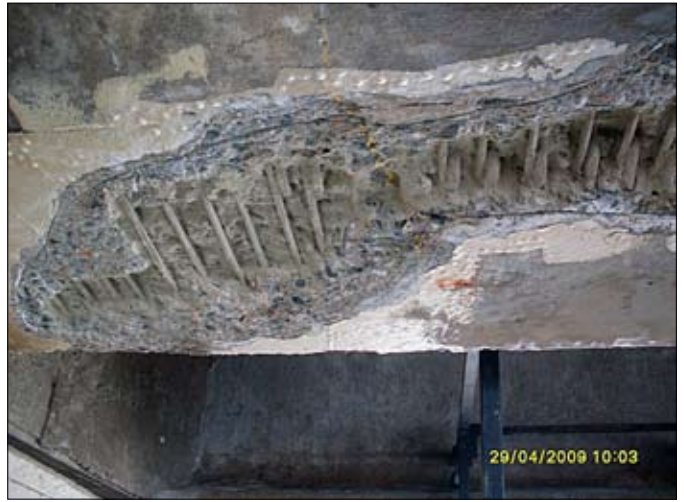
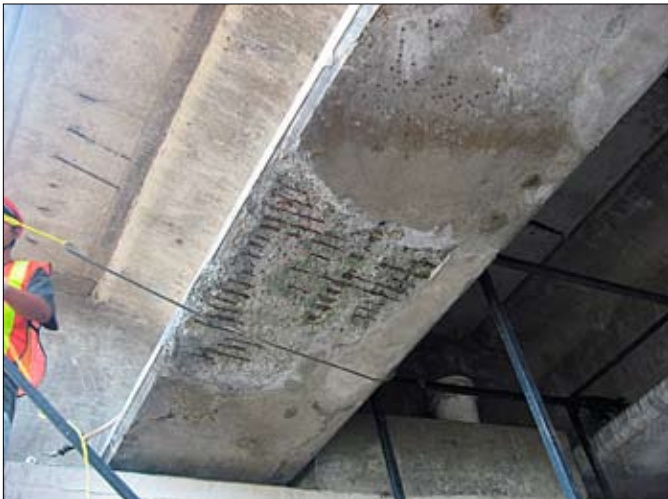
The precast beams of the Corredor Sur-Tramo Marino bridge were showing signs of corrosion from 10 years of exposure to the extreme surrounding environment. The bridge had to be repaired and protected from future corrosion problems.

The concrete beams were cleaned and prepared. All spalls and areas where corrosion was evident were chipped out. Rebar was exposed and rust was removed mechanically; in some places the rebar was replaced. Two coats of MCI® 2023 were applied on the exposed rebar, a repair mortar was used to patch the spalled areas, and a single coat of MCI® 2020 V/O was applied to the beams. Finally, the beams were painted with an epoxy protective coating.
