CASE HISTORY

Wilton Manors Bridge

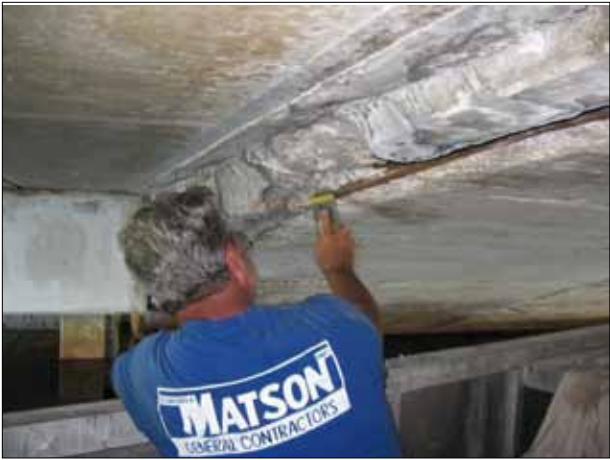
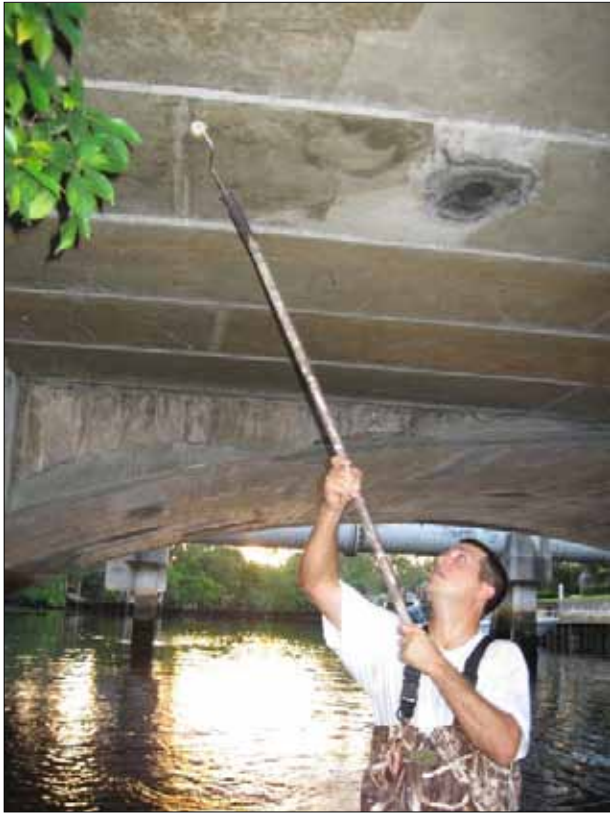
The bridge was spanning a salt water canal which exposed it to severe elements. Corrosion of reinforcement led to deterioration and spalling of the underside. Tidal changes in the area required the repair to be timed with the tide levels.

At low tide the dirt, grime, and loose concrete was removed. Then MCI®-2023 was applied by brush to all exposed rebar and damaged areas. The next day a second coat of MCI®-2023 was applied just before applying MCI®-2039 repair mortar. After curing the repair mortar MCI®-2020 V/O was applied to the underside of the bridge.
