ORGANIC CORROSION INHIBITORS – NEW BUILD AND EXISTING STRUCTURES PERFORMANCE

J. Meyer
Cortec Corporation, St. Paul, Minnesota, US

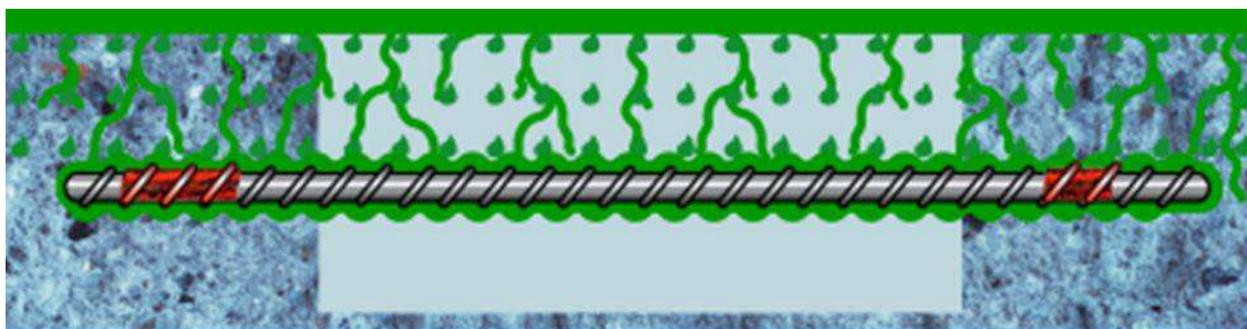
Figure 5. OCI Migrating Mechanisms – After liquid and vapour diffusion, showing final adsorption on metal to form a protective layer

Migrating corrosion inhibitors reach embedded reinforcement in several ways. First, the inhibitor is dispersed through the concrete with adequate mixing. The transportation of OCI within concrete then occurs via infiltration through concrete pore capillary networks. Thirdly, due to their relatively high vapour pressures, OCI move via diffusion in a gaseous state through the pore network and minor cracks. Finally, when the molecules come into contact with embedded metals, they have a specific attraction (as described above) to it. This process is illustrated in Figures 3, 4, and 5.

The molecules move randomly from areas of high concentration to areas of low concentration until equilibrium is reached (Fick's 2nd Law of Diffusion). Because of the final adsorption of OCI on embedded metal, the concentration gradient drives OCI to move towards the metal. X-Ray Photoelectron Spectroscopy (XPS) analysis has demonstrated the nitrogen rich layer (from amine moiety in OCI molecules) formed on rebar surfaces embedded in concrete that received a topical treatment of OCI. This protective, monomolecular layer also reduces the corrosion rate [4, 5].

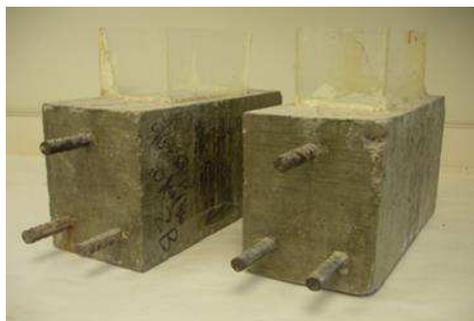
Figure 6. Example of ASTM G109 Test Blocks

ASTM G109 test samples can be seen in Figures 6 and 7 below. The test consists of casting concrete blocks containing a triangular arrangement of rebar embedded within them – one bar on top and two on the bottom. These samples are then exposed to cyclic wetting and drying cycles with salt water, and the macrocell current between the top bar and bottom two bars is monitored and recorded every 4 weeks (4 weeks = one cycle). The testing stops once the total integrated macrocell current reaches 150 Coulombs.

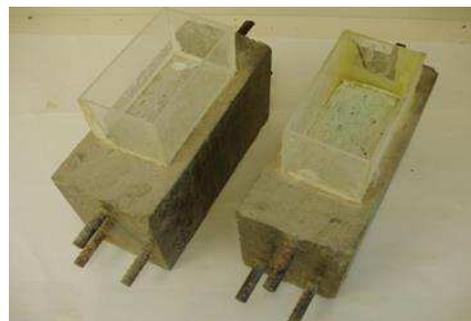
Figure 7. Example of ASTM G109 Test Blocks

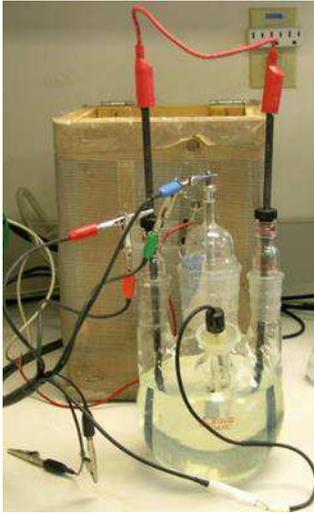
Figure 8. ASTM G180 Test Set-Up

The ASTM G180 – 13 [10] test setup can be seen in Figure 8. This test method provides a means for assessing corrosion-inhibiting concrete admixtures in a filtered cementitious liquid. Compared with a testing period of up to a few years required by ASTM G 109, this test method provides results within a few days. In this test, the polarization resistance of a steel sample is measured by applying a current through the test solution while varying the voltage. According to ASTM C1582, an admixture is behaving as a corrosion inhibitor when using the G180 Test Method (using 0.5 M NaCl with four control and four test specimens) if the mean $1/R_p$ value is less than or equal to $1/8$ the control average. Poor performance in G180 requires additional testing to determine if the admixture improves corrosion resistance.

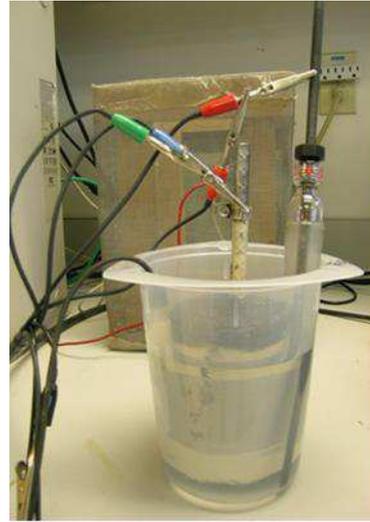
Figure 9. EIS Test Set-Up

Electrochemical Impedance Spectroscopy (EIS), Figure 9, is a powerful, rapid and accurate non-destructive method for the evaluation of a wide range of materials including coatings, anodised films and organic corrosion inhibitors on metal surfaces [11]. During EIS experiments, a small amplitude AC signal is applied to the metal system being studied. Data from EIS can provide detailed information on corrosion rate, electrochemical mechanisms, reaction kinetics, and detection of localised corrosion in a system.

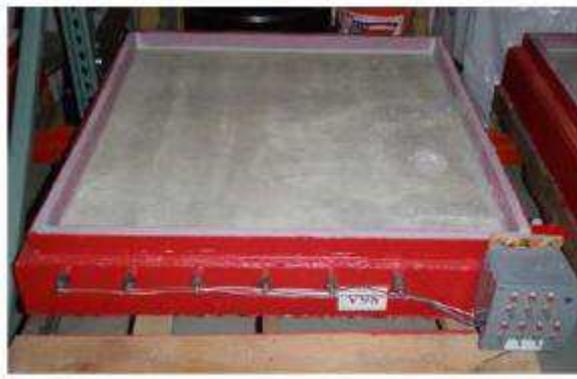
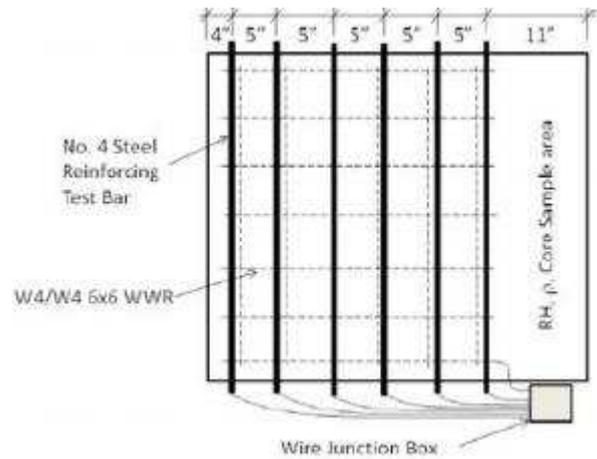
Figure 10. Photo and Bar Layout Diagram of M-82 Test blocks

M-82 involves the production of 101.6cm long by 101.6 cm wide x 13.97cm thick (all dimensions +/- 1.27cm) concrete slabs with discrete steel reinforcing bars near the top of the slab (~2.54cm from surface) and welded-wire reinforcing (WWR) near the bottom of the slab (~2.54cm from bottom), Figure 10. The steel bars are connected to the WWR through 1 ohm (Ω) resistors through switches in a junction box attached to the side of the slab. Concrete slabs are cyclically ponded with a 5% by mass sodium chloride (NaCl) solution for two weeks and then the solution is removed for two weeks (one test cycle). Macrocell current between each bar and the WWR is determined by measuring the voltage drop across the resistor within 24 hours of the start and immediately prior to the end of each ponding cycle. The positive macrocell currents (reinforcing steel bar is corroding) are integrated over time to have total macrocell corrosion for each bar. The total for all of the bars is also determined. The switches in the junction box are set so that all the bars and the WWR can be electrically connected through the resistors. For potential mapping the bars are connected.

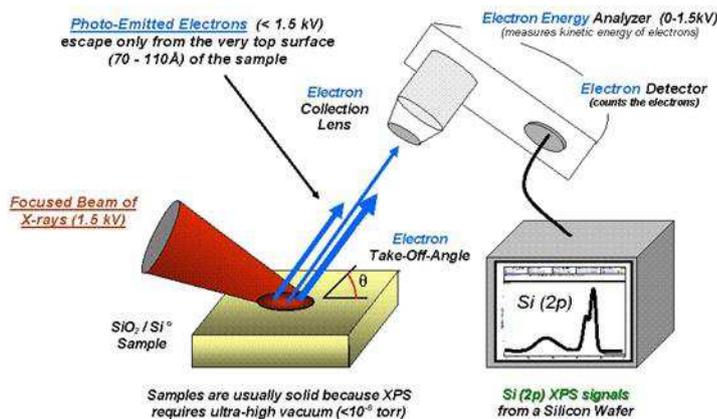
Figure 11. Diagram of XPS Process

XPS is a spectroscopic technique in which a beam of x-rays is focused onto the surface of a material and as the beam bounces off the surface it is received by an electron collection device. The data received is then analysed to determine the elemental composition of the material which reflected the x-ray beam. A diagram showing how XPS works can be seen in Figure 11.

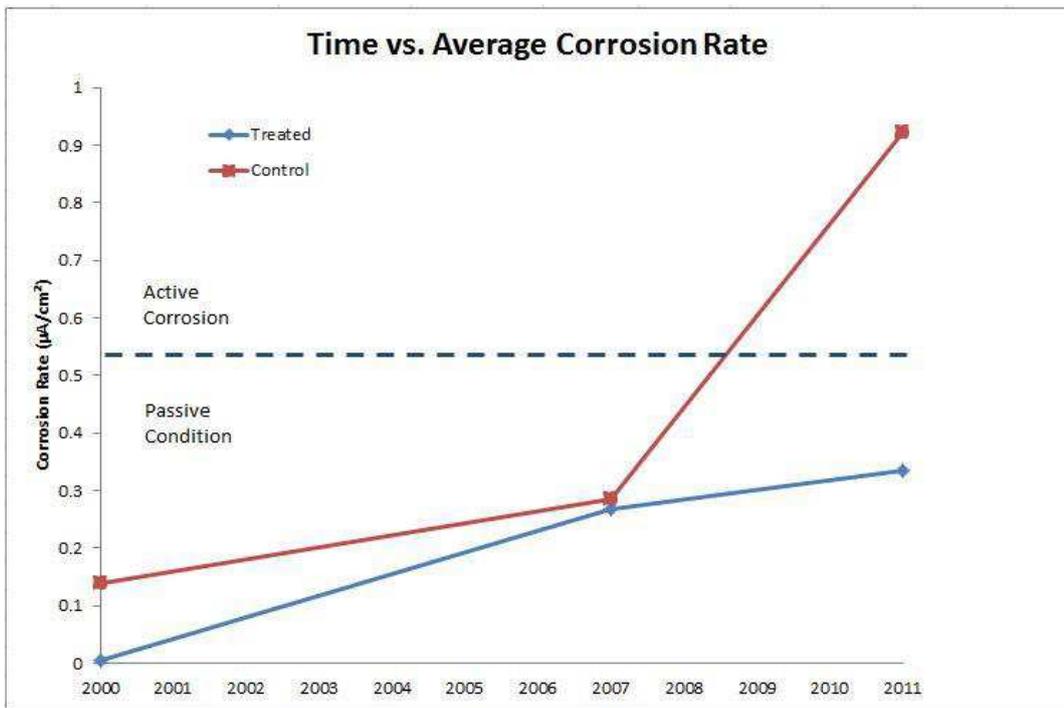
Figure 12. Randolph Avenue Bridge Average Corrosion Rates

Corrosion current readings, Figure 11, have increased on both sides of the bridge over time. Readings taken in July of 2011 showed that the control side had entered into active corrosion levels (corrosion rate readings above 0.5µA/cm²). All three sections tested indicated readings in the active corrosion range with the highest rate of corrosion recorded in the centre section of the control side, with an average reading of 1.27 µA/cm². In comparison, all three sections of the control side had readings in the passive range (corrosion rate readings less than 0.5µA/cm²), with the highest being the centre section with an average reading of 0.42µA/cm², indicating the treated side had roughly 67% lower rates than the untreated areas.

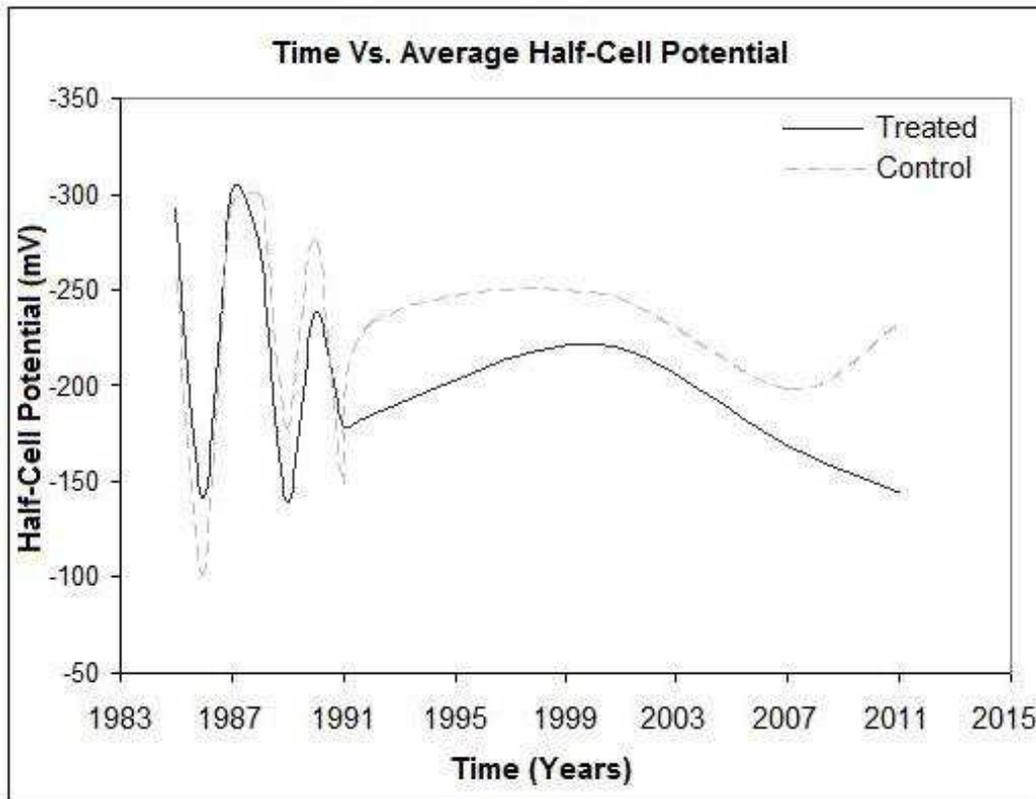
Figure 13. Randolph Avenue Bridge Average Corrosion Rates

Half-cell (electrode) potential readings can be seen in Figure 13. This figure shows that the electrode potential is more negative on the control side and has been for 20 years suggesting increased corrosion activity. This data along with the rest of the supporting information indicate that the level of corrosion on the treated side of the bridge is lower than the control areas.

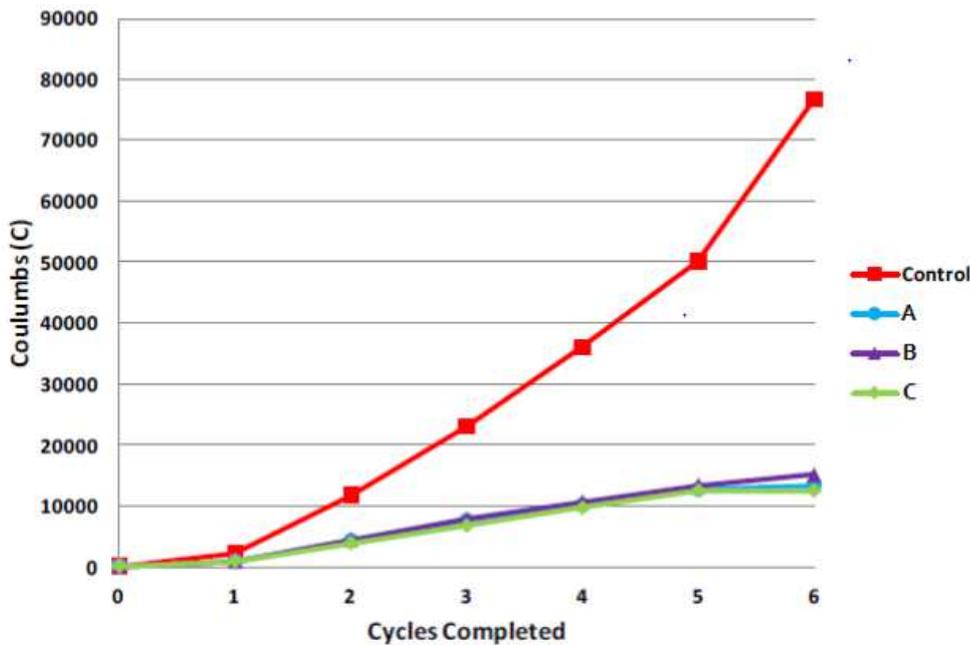
Figure 15. Average Integrated Current (After OCI Treatments) (USBR M-82 Protocol Configuration A Test)

At the end of testing, slabs were excavated and bars visually inspected for corrosion damage. The galvanic corrosion between the top bars and the wire mesh (macrocell current) is measured and integrated over time. Based on macrocell data, the majority of the corrosion on embedded bars occurred before the OCI treatments were made to the slabs. Figure 15 shows the average integrated corrosion current (coulombs) after OCI repair treatments were applied.

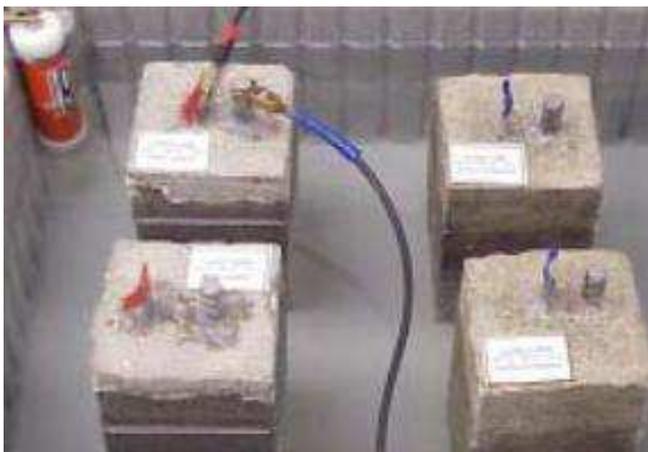
Figure 16. Modified ASTM G109 Test Set-up (continuous submersion)

Modified G109 testing was conducted on water based OCI inhibitors, Figure 16. The test lasted 1500 days and included over 200 cycles of 3.5%NaCl ponding/drying. It was found that the water based OCIs tested had increased polarisation resistance (R_p) (60-80 kohms*cm² with increasing trends) in the OCI coated concrete compared to controls, for both low density (2.08 g/cm³, 0.65 w/c) and high density (2.40 g/cm³, 0.35 w/c ratio) concretes. The untreated not only had lower R_p values, but also decreasing trends, refer to Figure 17.

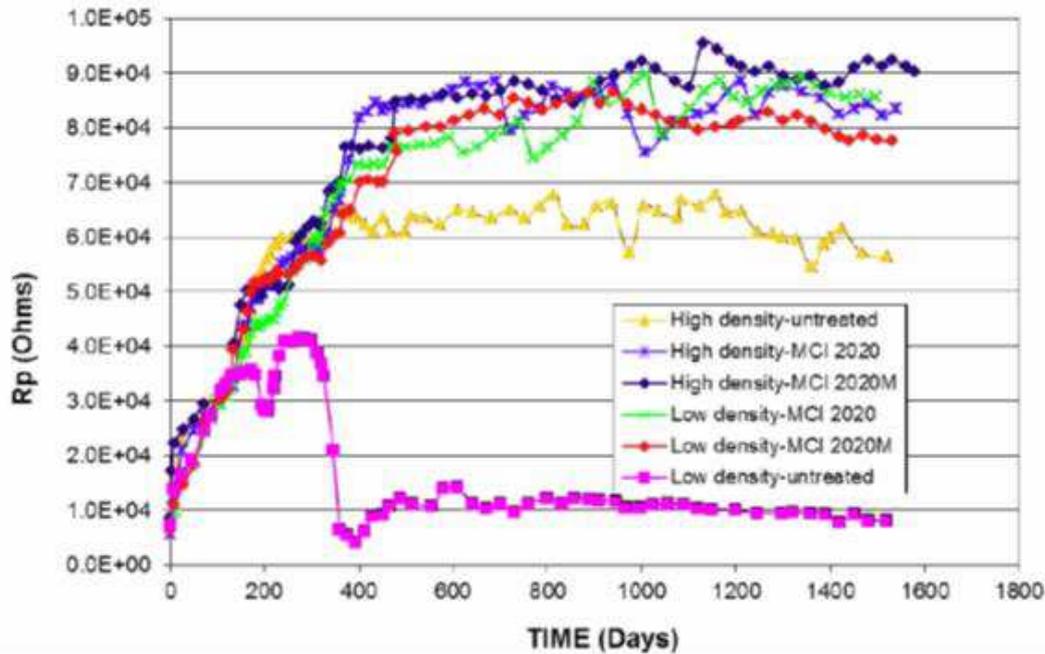
Figure 17. Comparison in Polarization Resistance (Rp) in Low & High Density Concretes – OCI Treated vs. Untreated

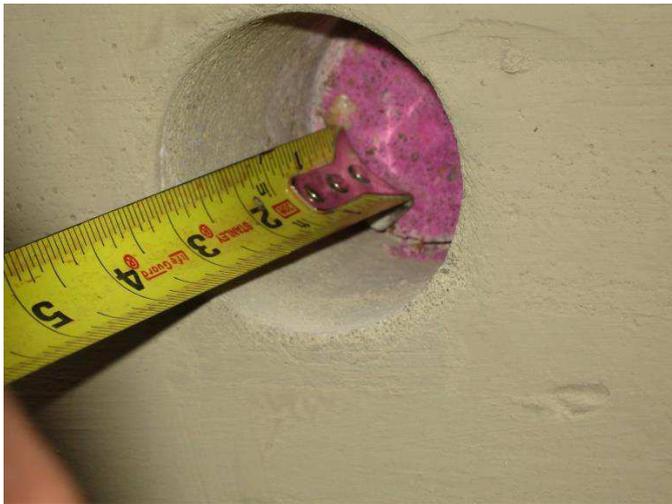
Figure 18. Carbonation Testing on Lightwell Wall

PENREN, the governing agency for the renovations, dictated that the repairs must last 50 years, which meant a detailed inspection was completed by the consulting engineer, and extensive repair methods were considered. Concrete testing completed during the inspection revealed that the walls were carbonated to a depth of 76-102 mm with the outer layer of reinforcing steel approximately 13 mm from the surface, refer to Figure 18. Furthermore, the surface of the concrete was very porous as a direct result of the rough cut lumber used for forms during original construction of the building. This environment caused corrosion on embedded reinforcing steel and deterioration of the concrete walls as can be seen in Figure 19.

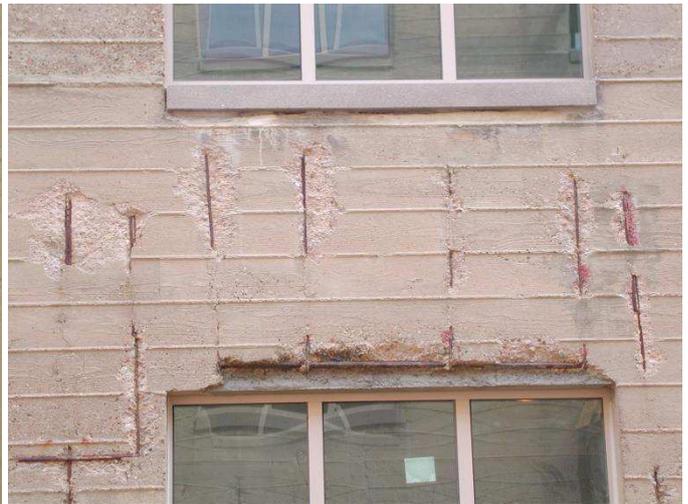
Figure 19. Example of Corrosion on Lightwell Walls Prior to Repair

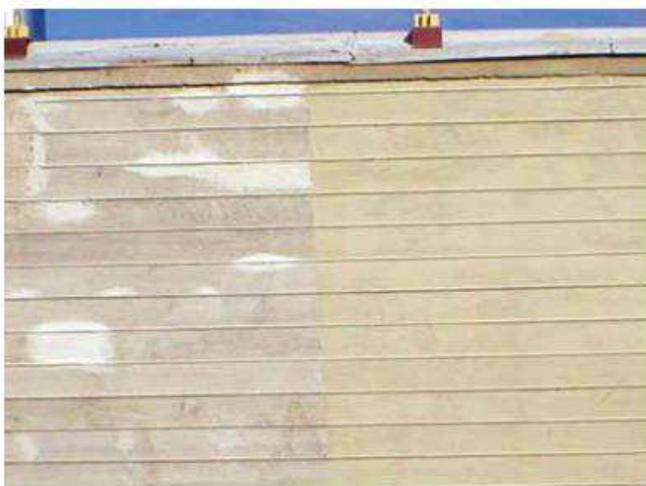
Figure 20. Before and After Coating Application

Once cleaned, exposed reinforcing steel was treated with a zinc rich, acrylic based, corrosion inhibiting coating and new proprietary polymer modified cementitious patching material was installed. Patch material and forms were designed to match the existing façade in colour and texture. When concrete repairs were completed, all surfaces of the building were cleaned and treated with a water based OCI formulated for vertical and overhead applications to help compensate for the loss of alkalinity around the steel (due to carbonation) and reduce corrosion rates. This treatment was then followed by a 100% silane sealer for water repellency, and then a mineral based, potassium silicate coating to create a uniform finish to the building exterior, Figure 20 and Figure 21.

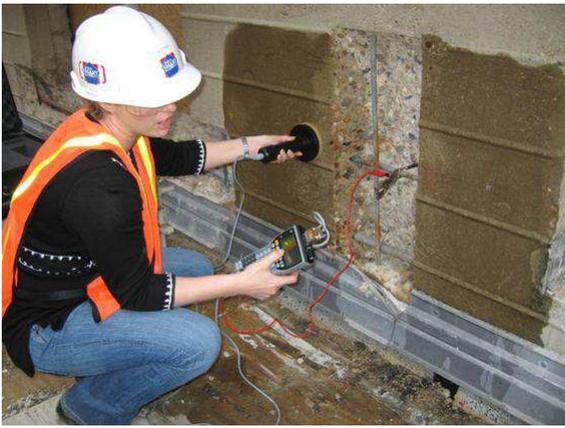
Figure 22. GalvaPulse Readings Prior to Repair

During the repair years, linear polarisation readings were taken in selected areas of the lightwells using a GalvaPulse device [22], Figure 22, every spring and fall to ensure that corrosion was being mitigated with the repairs and that the design life would be achieved. A wire (cable) was installed on embedded reinforcing steel during the repairs and run outside of the wall to use to attach the GalvaPulse to for future readings. Since the silane and silicate surfaces changed the resistivity of the concrete surface, small test areas were left free of coating to allow for the taking of concrete resistivity readings in the future. An example can be seen in Figure 23.

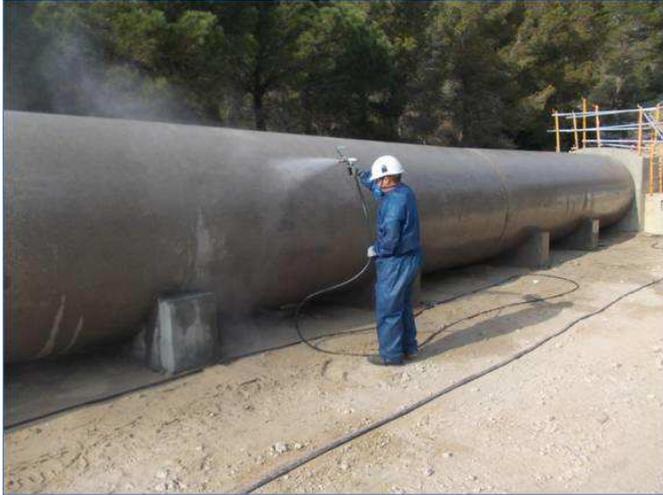
Figure 24. Spraying OCI onto the Pipeline

Consorci D'Aigües De Tarragona (C.A.T.) is the non-profit water consortium authority responsible for high pressure drinking water in the Tarragona region of Spain [34, 35]. C.A.T. had a 30 year old network of prefabricated, reinforced concrete pipes that were carbonated and experiencing corrosion problems. Restoration began in 2014 with damaged concrete removal and repairs completed using a cementitious bonding agent on exposed bar and repair mortars that contained OCI inhibitors certified for use on potable water structures. More than 7,000m² of repair were completed in this manner. After repairs were finalised, the entire length of the pipe was treated with a topically applied OCI (more than 13,000m²), Figures 24 and 25. Testing done after application showed that corrosion rates had dropped and the authorities were pleased with the results. Due to the success of the repair, C.A.T. has since implemented the use of OCI admixtures on the construction of their new potable water reservoirs.

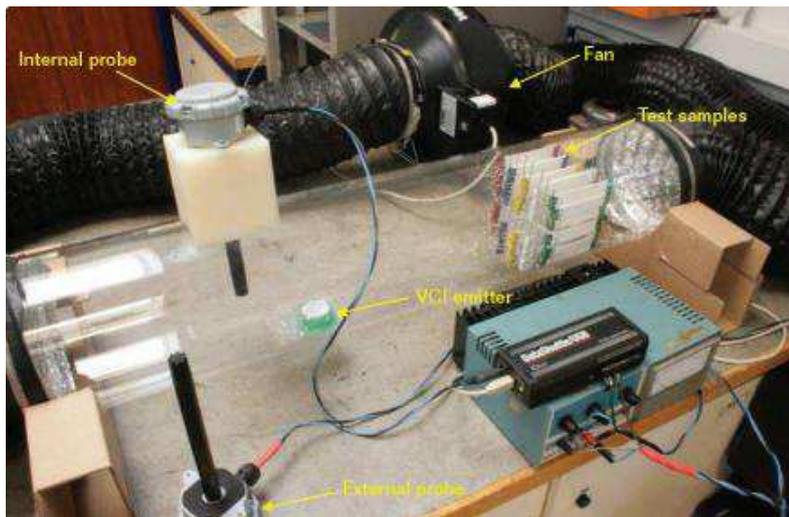
Figure 26. Laboratory Testing to Confirm OCI Compatibility with Dehumidification System **Figure 27. View of Severn Bridge**

For these reasons, a powder version OCI, contained in a vapour permeable pouch, was developed to introduce pure inhibitor vapour into the system using the dehumidification air stream as the carrier. This ensured a sufficient level of inhibitor would be present within the air voids to protect exposed metal surfaces while avoiding the risks of blockage by solid or liquid material. Because the protective inhibitor layer is at a molecular level, it has no influence on clearances and had only a minimal effect on other physical properties. Testing showed that use of the inhibitor caused a small increase in wire-to-wire friction at low contact pressure and no significant frictional effect at higher loads. Further testing was carried
