CASE HISTORY

Northwest Paper Mill Recovery Boiler Concrete Slab Replacement

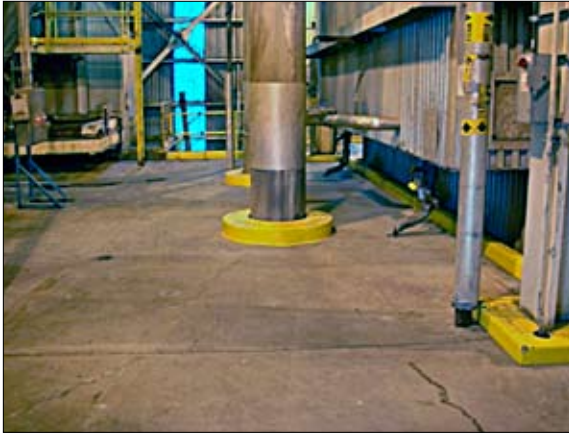
A paper mill, located in the Pacific Northwest region of the United States, was experiencing corrosion from sulphur dioxide gas, SO₂. Concrete was in danger of falling 25 feet between deck levels. Concrete curbs were severely deteriorated and drainage needed to be re-sloped. Wall cladding would be difficult to remove because it was transite, a combination of asbestos and cement. Therefore, the customer determined that the anchoring needed to stay.

MCI® 2005 AL was used as an admixture in all of the concrete to protect against SO₂ corrosion and the ring anode effect at the transite anchors.

Cortec® products provided a solution to the customer where they were able to repair the concrete slabs and they did not need to disturb the asbestos cladding.
