CASE HISTORY

Emergency Stabilization of Alcatraz

National Park Service

San Francisco Bay, CA

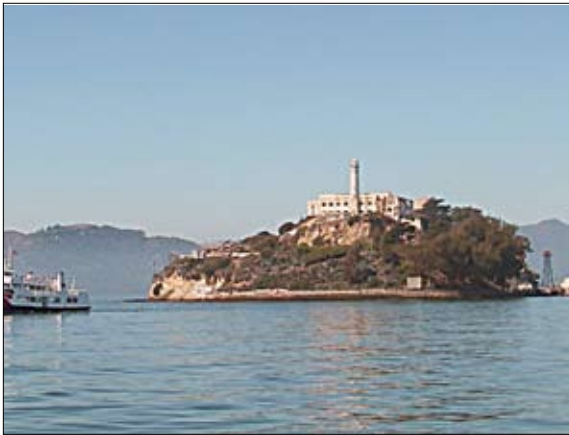
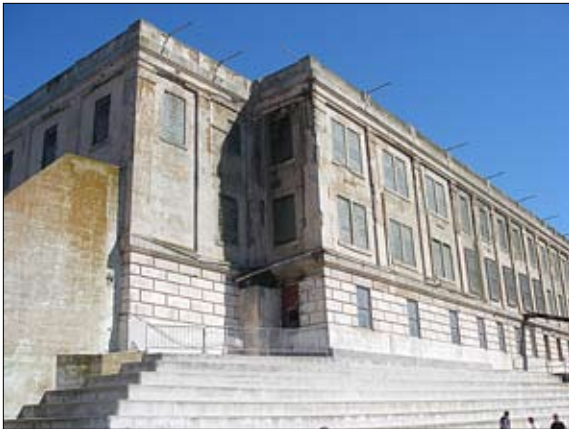
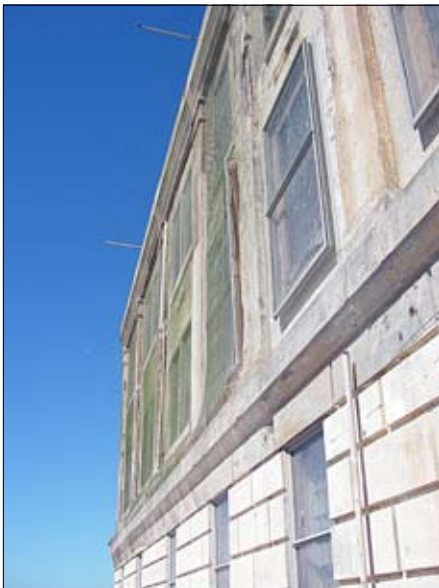
Alcatraz Island is the site of the well known Alcatraz Federal Penitentiary. This island is located in the center of San Francisco Bay and being surrounded by salt water and fog year round causes numerous corrosion issues for the current stewards of Alcatraz, the National Park Service (NPS). Alcatraz Island receives over a million tourist visitors a year and their safety is paramount to the NPS staff. When the NPS noticed the potential hazard of loose concrete on walls of the main prison building high above the open visitor areas, they contacted their Cortec® distributor for solutions. The hazardous falling concrete had to be removed and the corrosion slowed with a limited budget. Further complicating the work schedule is the fact that Alcatraz is also a sanctuary for seabirds such as cormorants and pigeon guillemots, and for waterbirds such as snowy egrets and black-crowned night herons. Nesting birds are censused on a yearly basis, and management actions are adjusted to avoid disturbance during this sensitive time. Therefore work is prohibited from February through September.

To slow corrosion the NPS staff removed the loose spalled concrete and applied CorrVerter® to the exposed steel then the entire area was treated with MCI® 2020 to address corrosion that was undoubtedly beneath the surface.
